CURVED DAM-LOCK 7

INVENTORY Nº NY 398

PHASE I INSPECTION REPORT NATIONAL DAM SAFETY PROGRAM.

Curved Dam-Lock 7 (Inventory Number NY 398), Oswego River Basin, Oswego County, New York, Phase I Inspection Report,

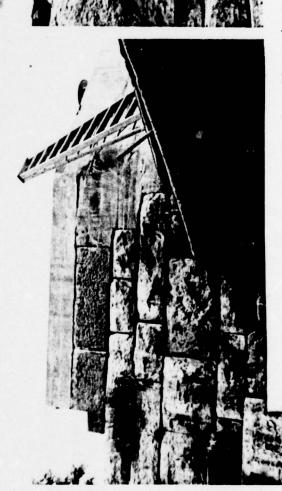
. Masonry head wall on east side of spillway shows some movement of masonry units. Opening below spillway apron caused movement of masonry element above it.

Some lateral displacement in the stone block headwall for the curved dam's east abutment has apparently occurred. The condition appears to have had no effect on the adjacent dam section.

- Seepage and leaks through and beneath the dam should be repaired.
- The east abutment masonry units should be aligned and the missing masonry unit replaced.
- The boil on the riverside wall of the navigation channel should be investigated and the condition corrected.

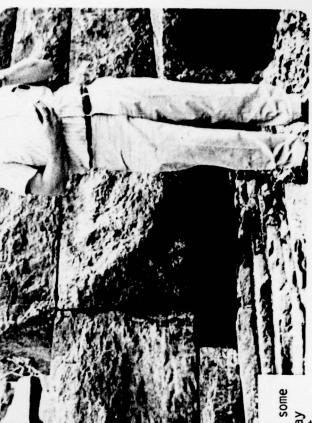
3. Examples of seepage through masonry joints.

The stone blocks comprising the downstream face of the dam are limestone. The blocks were observed to be in good condition. Leaks between the blocks are not attributed to block deterioration.

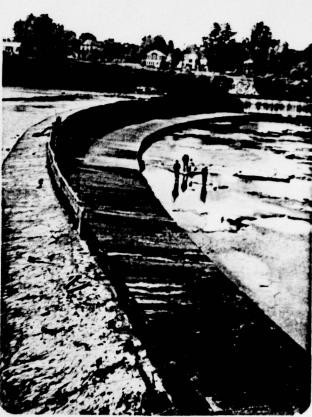
4. Through or under the dam flows were located below the apron in the center of the dam as shown in the close-ups. These flows can be seen just beyond the people. The second location is approximately 25 feet beyond the first.

Visual inspection reveals spurting leaks through the masonry of the curved dam and through or under the dam seepage under the apron of the curved dam. A boil was observed along the base of the upstream approach channel to Lock Number 7. The dam is founded on bedrock and shows no other evidence of structural problems or instability. No major deformation of the alignment of the structure was noted in the visual inspection.

The through-the-dam seepage condition needs to be further evaluated. This investigation should be undertaken immediately and completed within one year from notification. Upon completion of the investigative phase, required design and construction should commence and the remedial work should be completed within two years of notification.

To prevent the development of potentially hazardous conditions, seepage condition investigations should be performed to determine remedial measures to repair the seepage and evaluate the existing stability of the spillway. This work should include subsurface investigations involving borings.

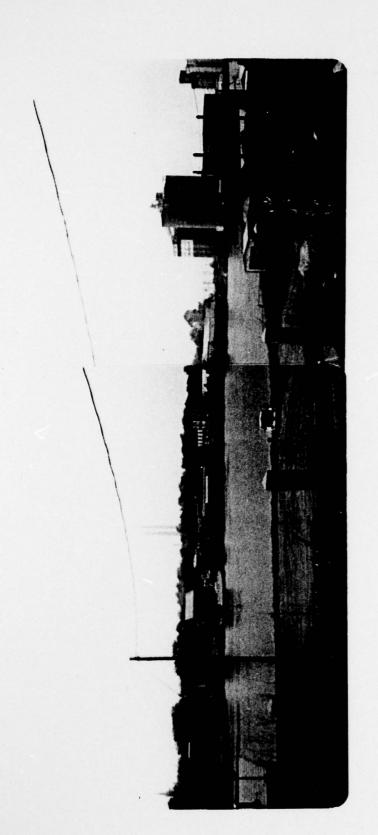
6. Downstream hazard area in the City of Oswego.
